P/N SP-114

**COMMANDER 114 SERIES
SERVICE PUBLICATIONS**

The following is a numerical list of all active Service Bulletins.

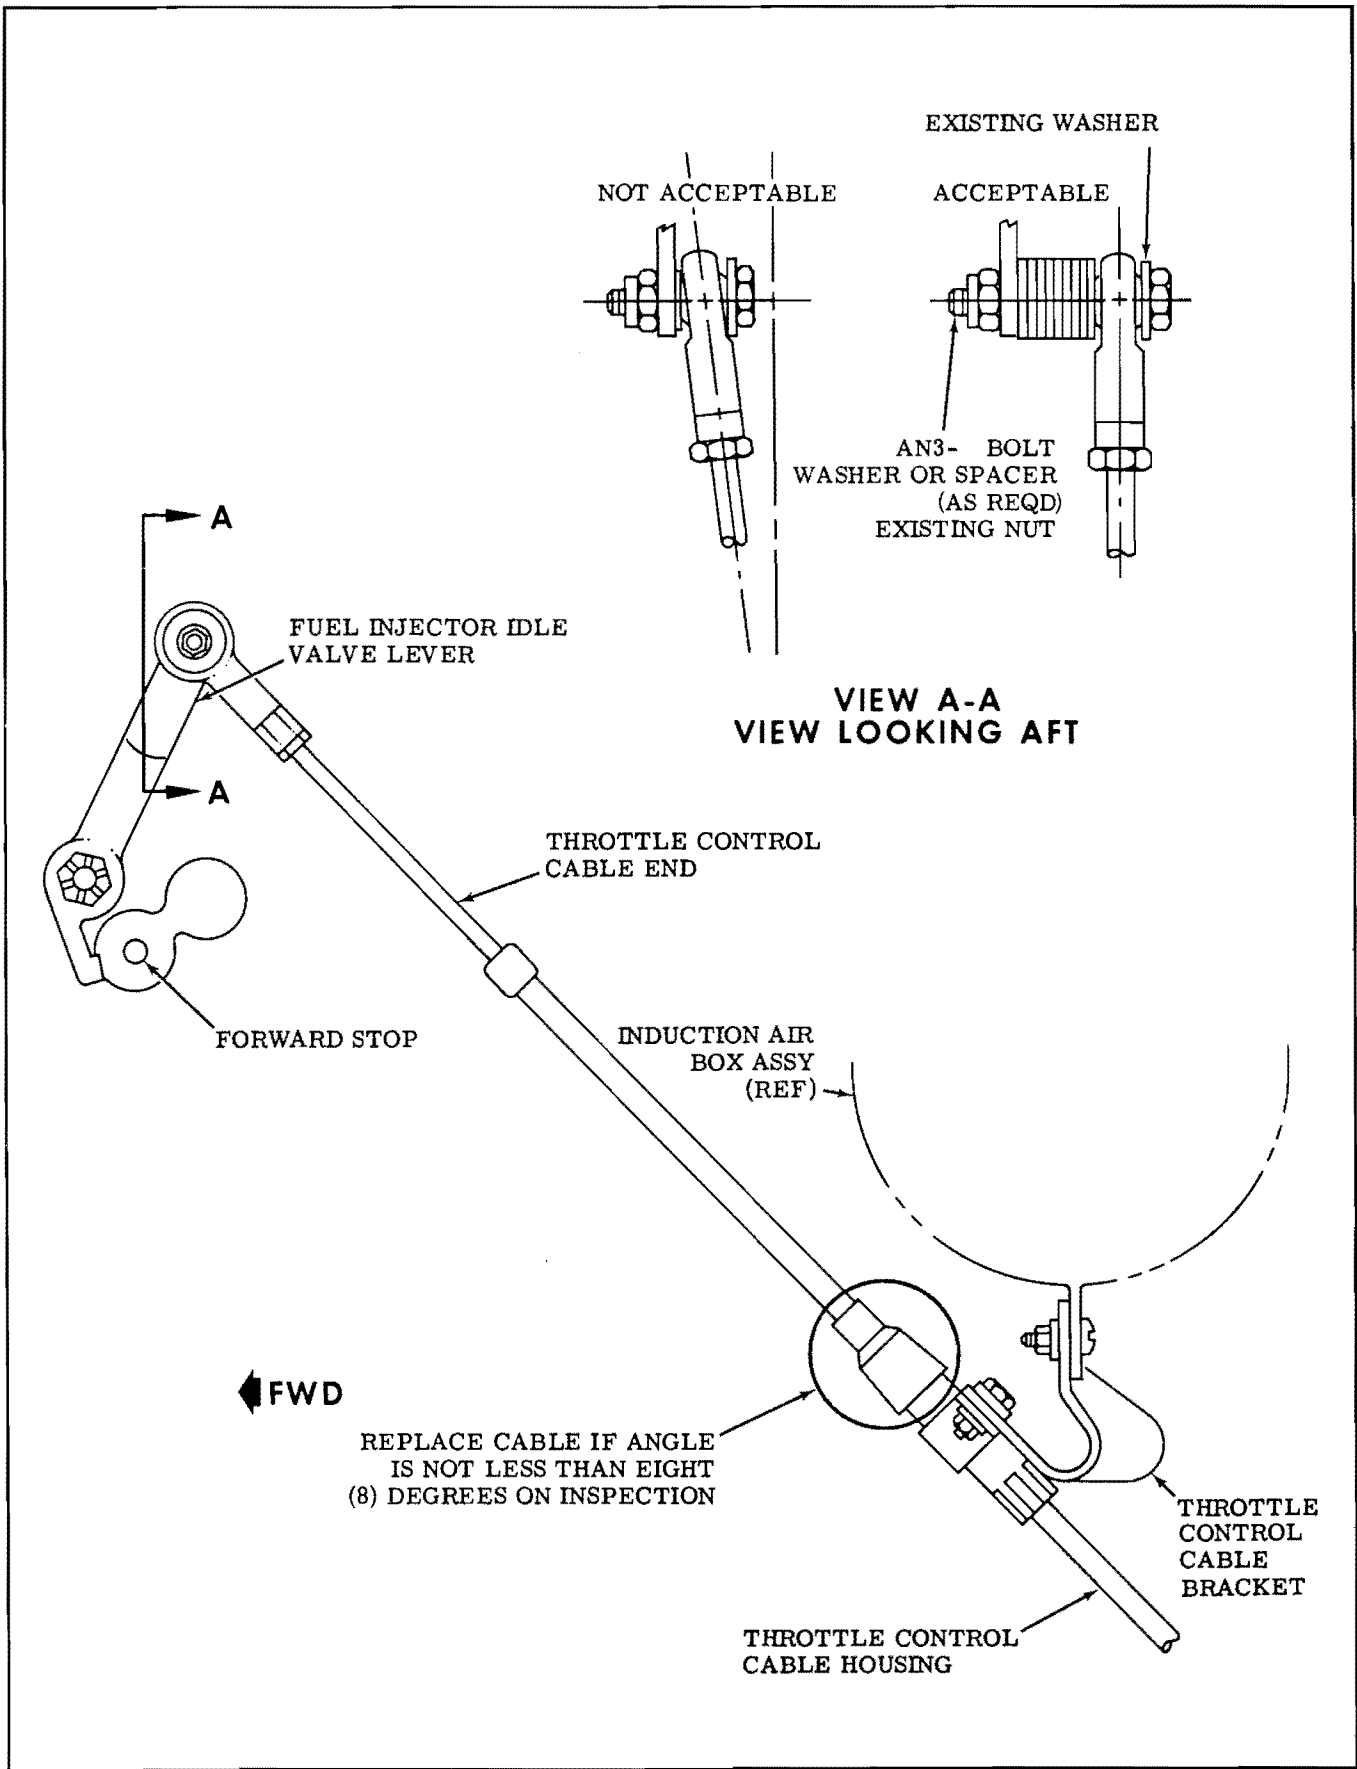
Figure 1.

MODELS AFFECTED: MODEL 114, SERIAL NO'S 14000 THRU 14149.
REASON FOR PUBLICATION: TO PREVENT POSSIBLE THROTTLE CONTROL CABLE FAILURE.
COMPLIANCE: PART I - UPON RECEIPT OF THIS SERVICE BULLETIN.
PART II - UPON AVAILABILITY OF PARTS.

1. Remove upper and lower engine cowling as outlined in the Model 114 Airplane Maintenance Manual, Section IV.
2. Inspect throttle control cable for misalignment. If misalignment is not less than eight (8) degrees (see Figure 1.), replace cable when complying with Part II of this Service Bulletin.
3. With the throttle in mid-point of the stroke, bend throttle control cable bracket as necessary so that cable housing is straight with cable end (see Figure 1.).
4. With the throttle in mid-point of the stroke, inspect throttle control cable at the fuel injector idle valve lever for proper alignment (see Figure 1.).

If throttle control cable has not been operating at less than eight (8) degrees angle as determined in Part I, replace throttle control cable (P/N 46135-3).

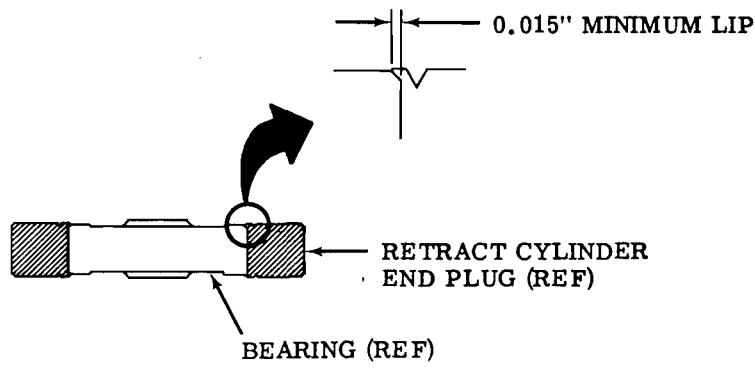
Figure 1.

REASON FOR PUBLICATION: SOME RETRACT CYLINDER END PLUG BEARINGS HAVE SLIPPED OUT OF END PLUG DUE TO INADEQUATE STAKING. THIS SERVICE BULLETIN IS BEING ISSUED TO CORRECT THIS SITUATION.

2. If bearings are staked properly, proceed to step 5.
3. If improper staking is found, remove left and right main landing gear retract cylinders as outlined in the Airplane Maintenance Manual, Section III and hand stake bearings using a 1/8-inch chisel (see Figure 1.).

4. Reinstall left and right main landing gear retract cylinders as outlined in the Airplane Maintenance Manual, Section III.
5. Fill out and mail Compliance Card.

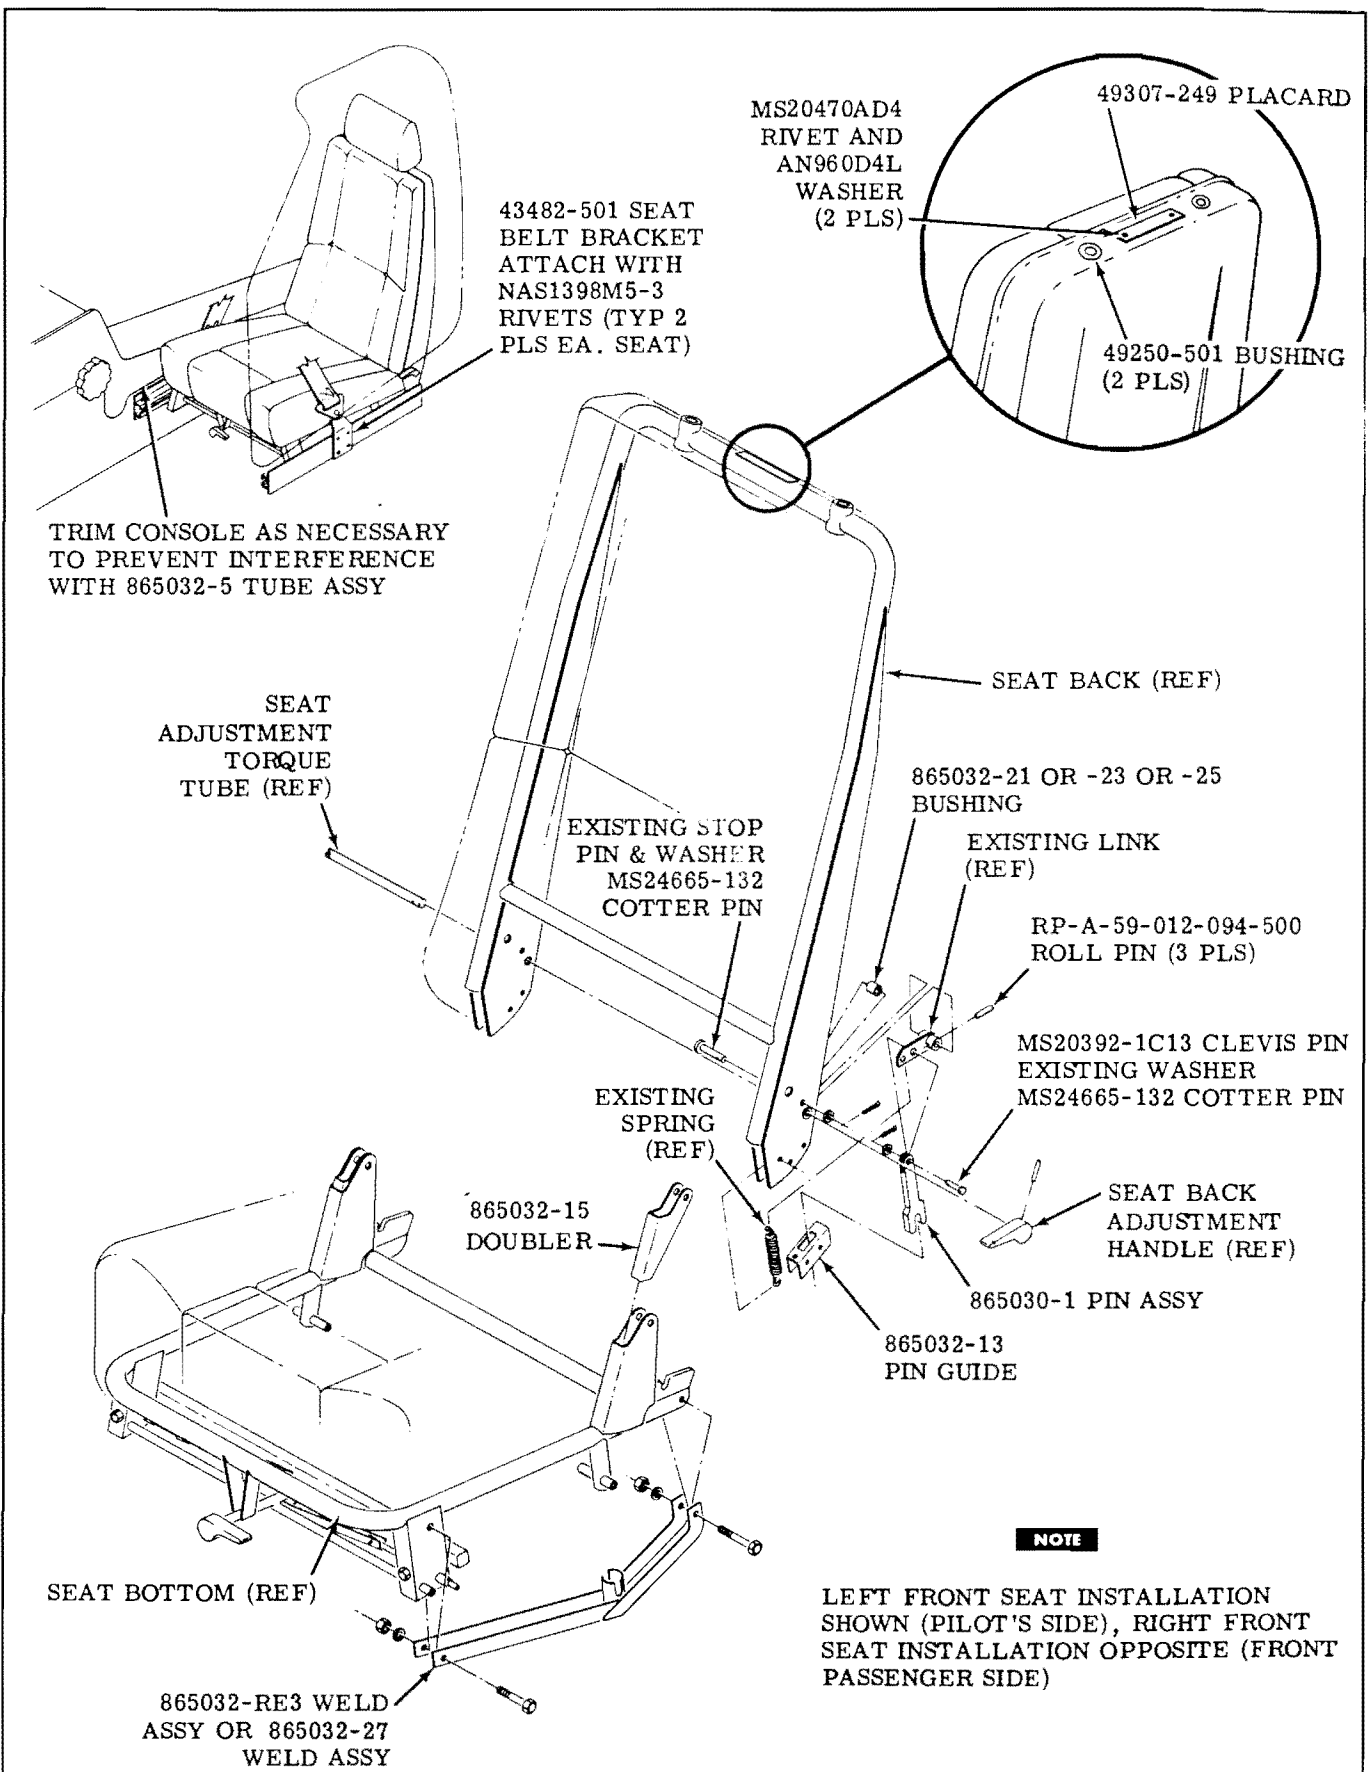
Figure 1. (Sheet 1 of 2)

Mismatch shall not exceed 0.065 inch.

- n. If mismatch exceeds 0.065 inch, pull roll pin attaching link to seat adjustment torque tube, seat pin assembly to mate ratchet, redrill link and seat adjustment torque tube approximately 45 degrees to 90 degrees from original position and reinstall existing roll pin.

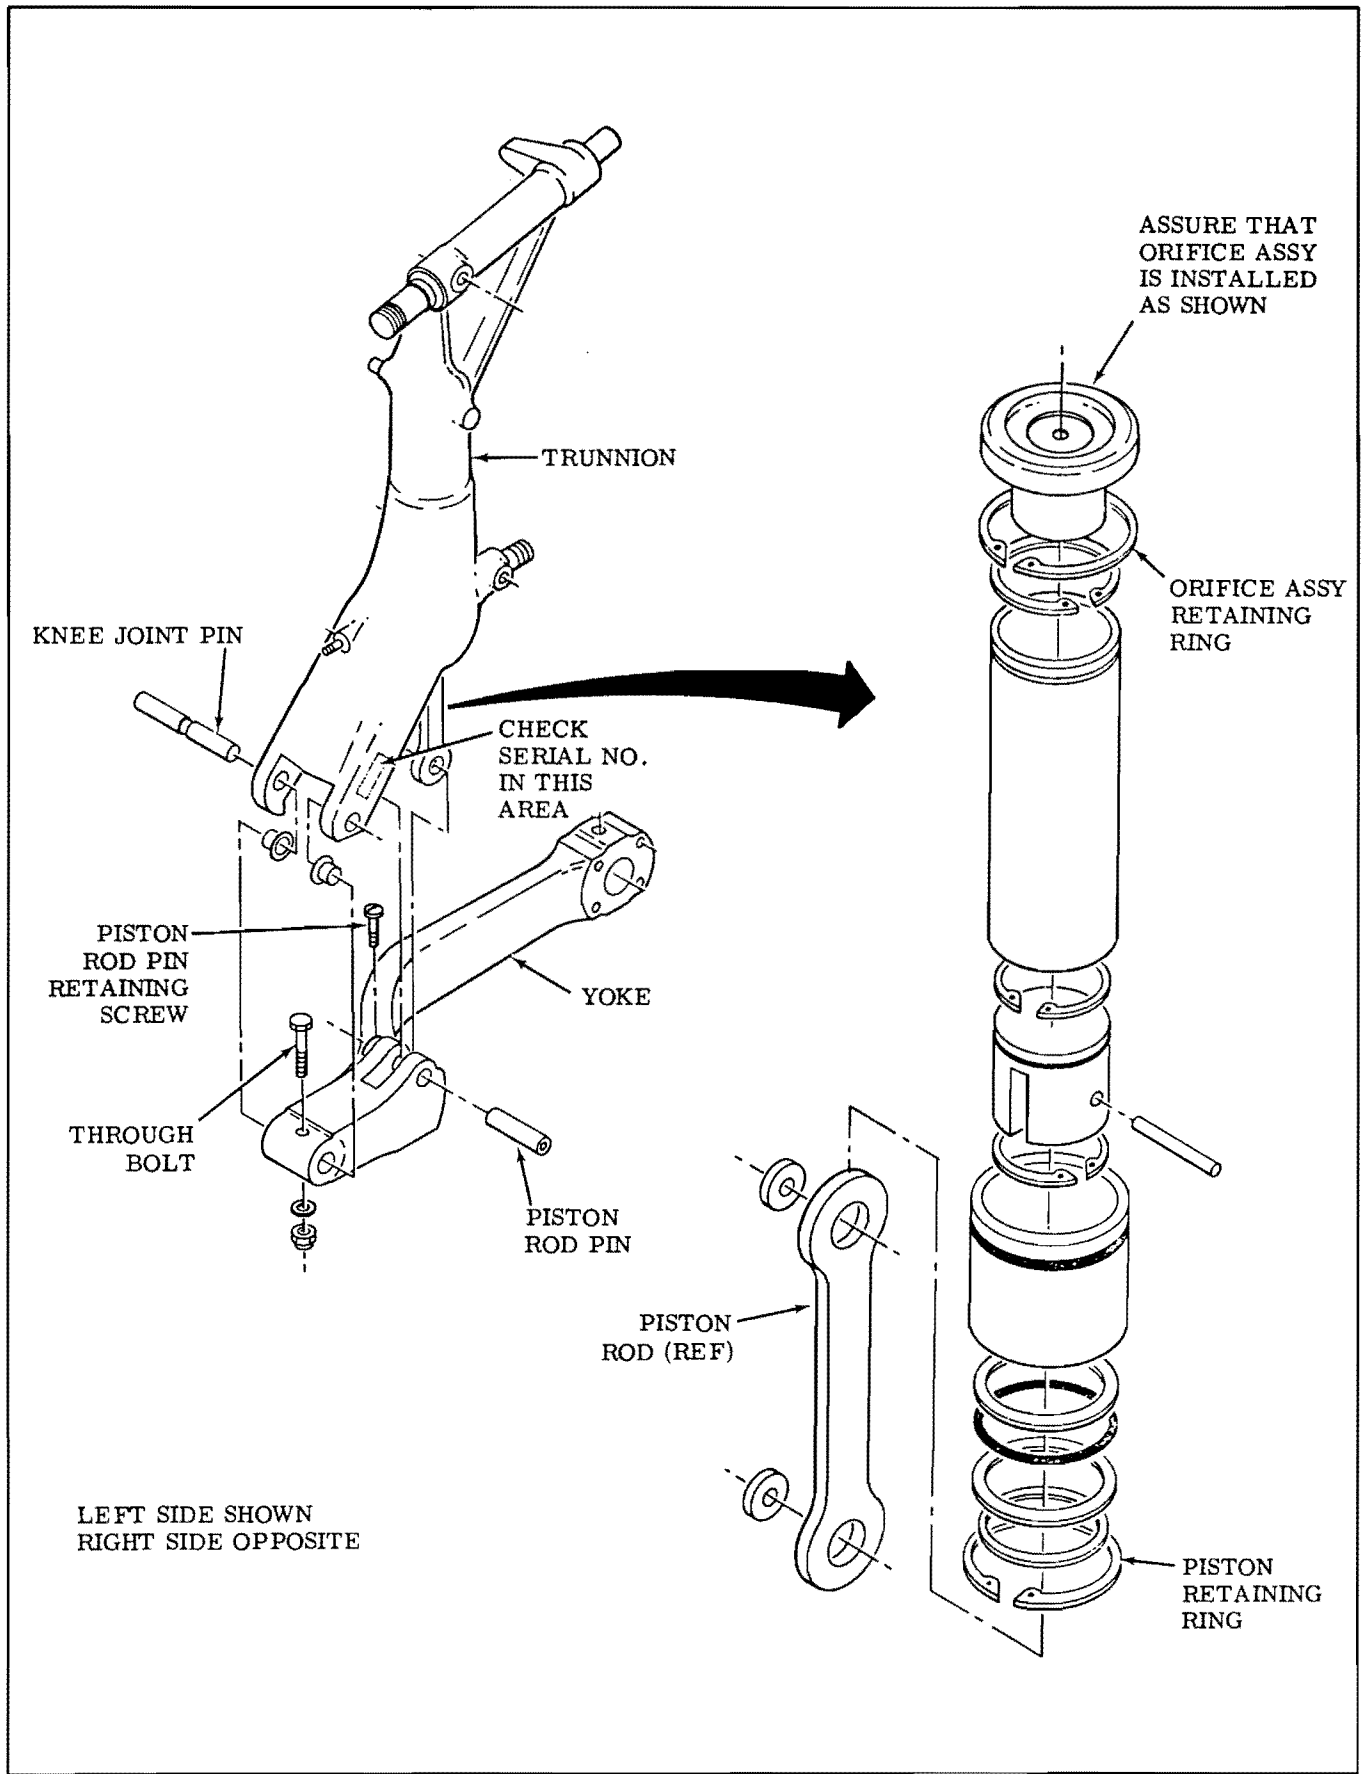
Figure 1.

REASON FOR PUBLICATION: ON SOME AIRPLANES, THE ORIFICE ASSEMBLY (P/N 725001-1) MAY HAVE BEEN INSTALLED IMPROPERLY IN THE MAIN LANDING GEAR. THIS SERVICE BULLETIN IS BEING ISSUED TO CORRECT THIS SITUATION.

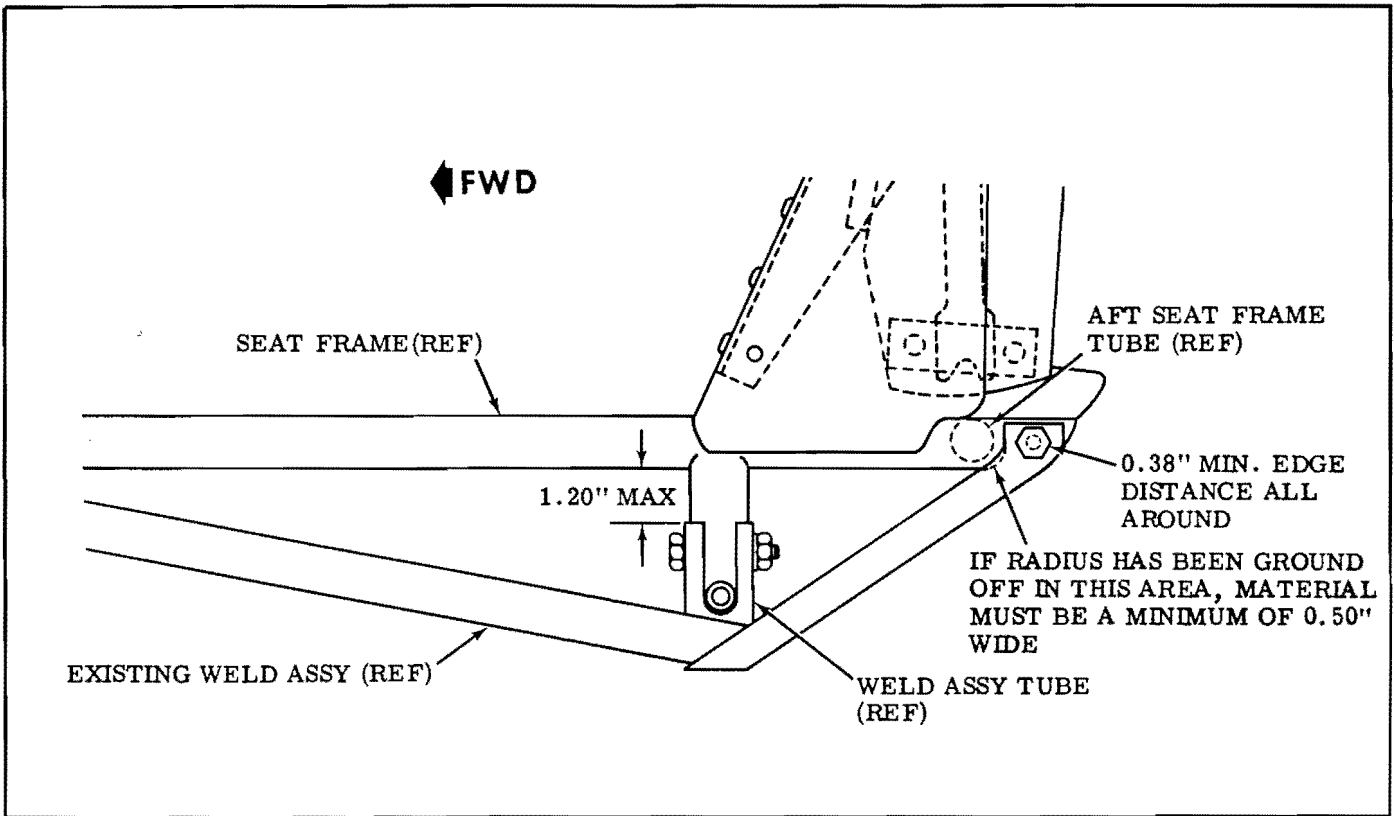
1. Inspect weld assemblies, installed on outboard side of pilot seat and front passenger seat, for correct installation dimensions as shown in Figure 1.
2. If dimension between weld assembly tube and seat frame exceeds 1.20-inches, proceed to Part II (see Figure 1.).

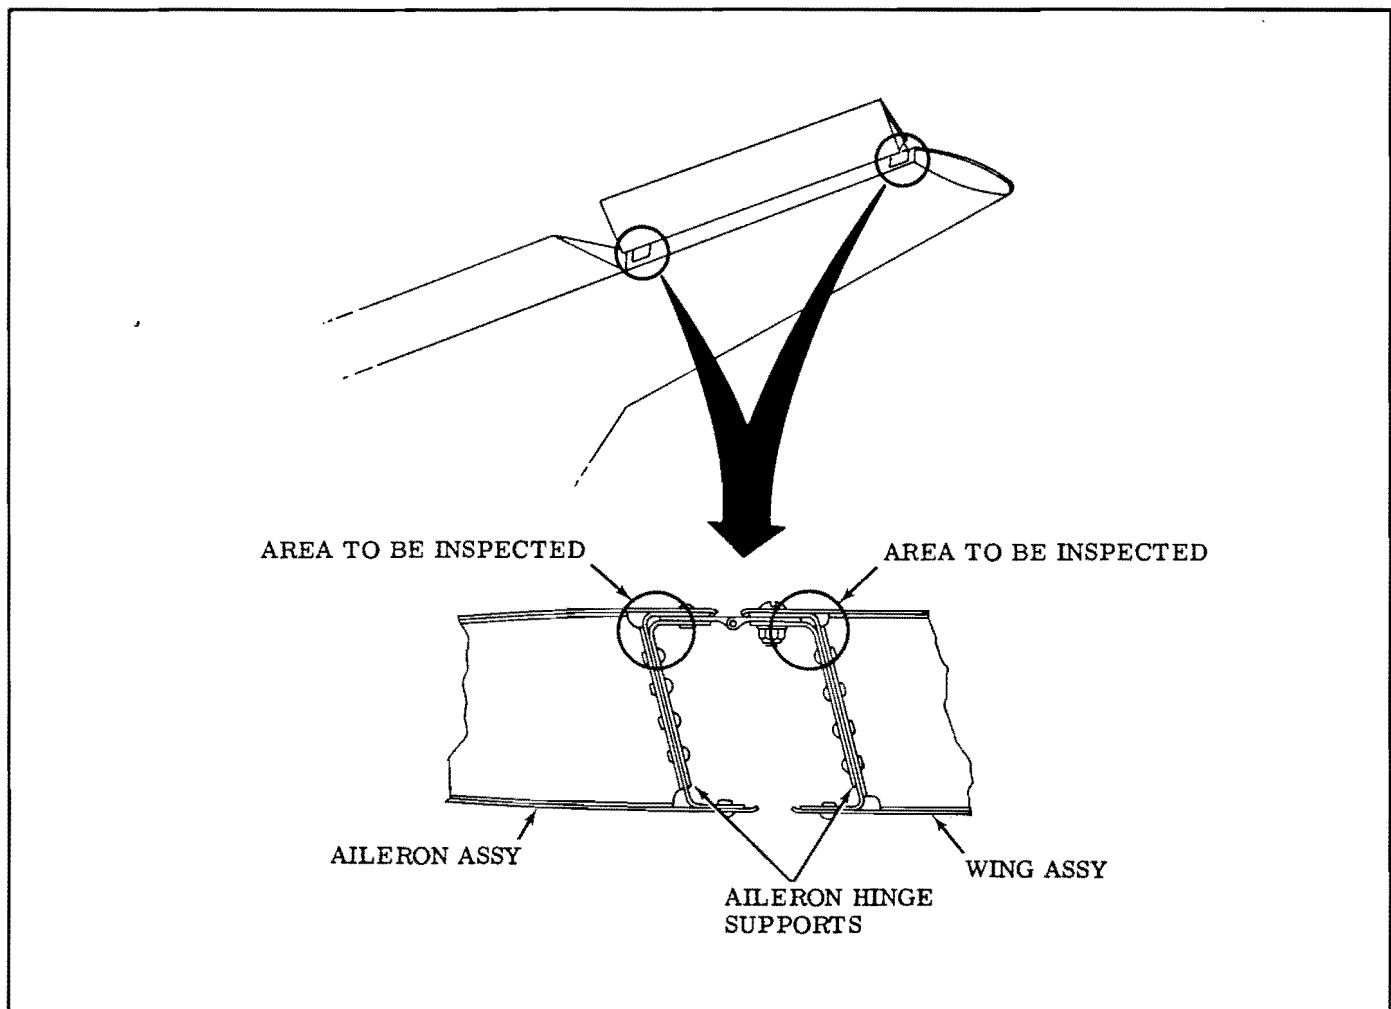
Figure 1.

REASON FOR PUBLICATION: POSSIBLE CRACKING OF AILERON HINGE SUPPORTS.

4. Dye penetrant inspect all aileron hinge supports for possible cracks in areas of bend radius (see Figure 1.).
5. If cracks are found in any aileron hinge support, proceed to Step 2. of Part II.

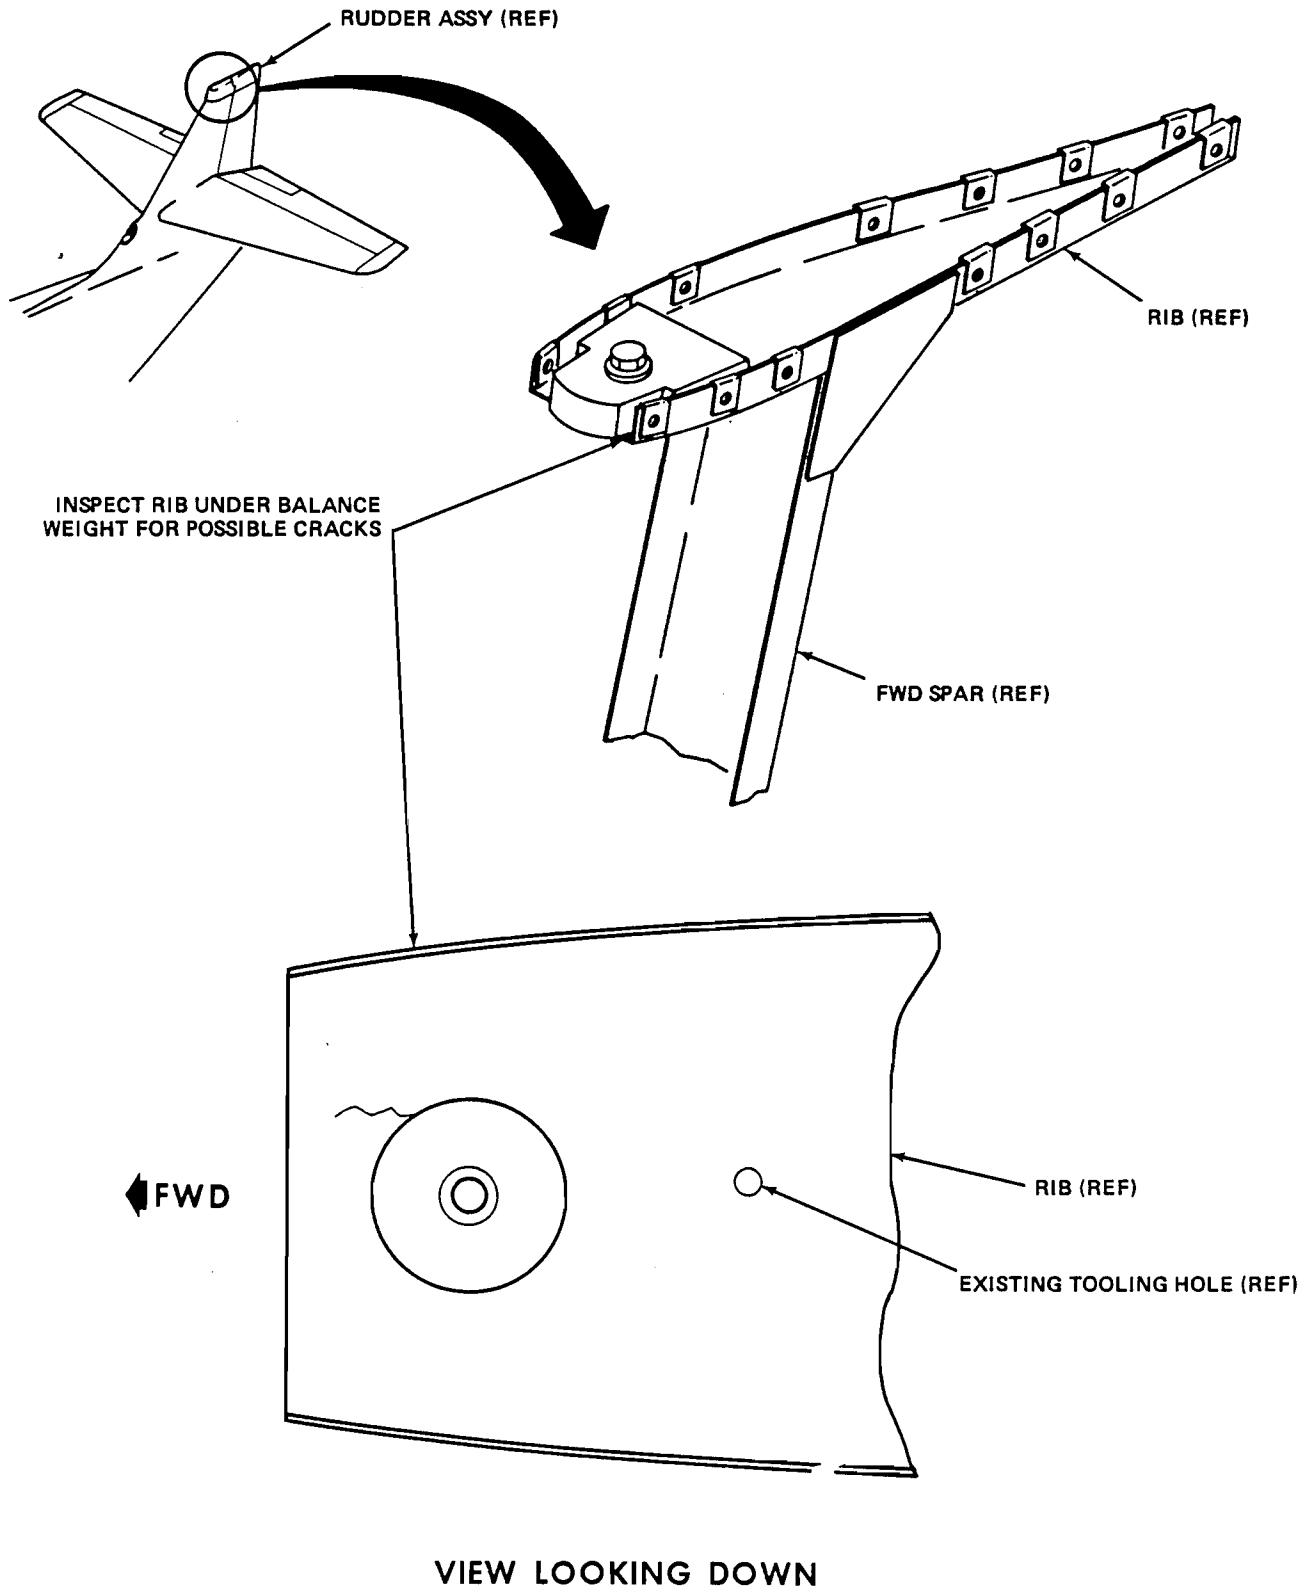
Figure 1.

REASON FOR PUBLICATION: POSSIBLE CRACKS IN RUDDER TIP RIB AT BALANCE WEIGHT ATTACH HOLE.

1. Inspect rudder tip rib in area around balance weight attaching hole to check for cracks (refer to Figure 1).

2. If no cracks are found, proceed to step 4.
3. If cracks are found in area of balance weight attaching hole, proceed to Part II of this Service Bulletin.
4. Fill out and mail Compliance Card specifying that Part I of this Service Bulletin has been accomplished. Note if any cracks were found.
5. Proceed to RECORD COMPLIANCE.

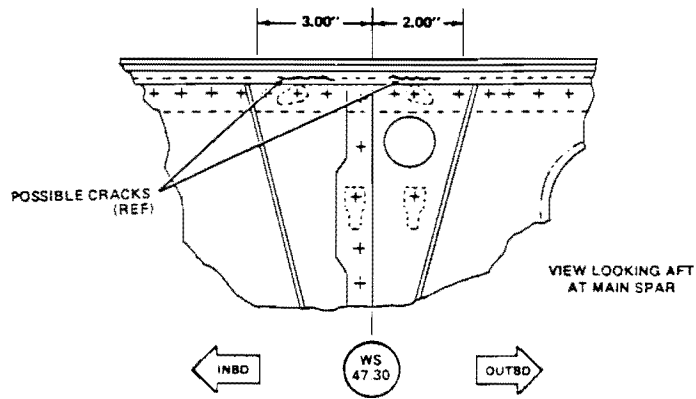
- a. If upper bolt holes are cracked and cracks are found in radius of spar cap and cracks in radius extend less than 3.0 inches inboard or 2.0 inches outboard of wing station 47.30 trace, comply with Part IV of this Service Bulletin.

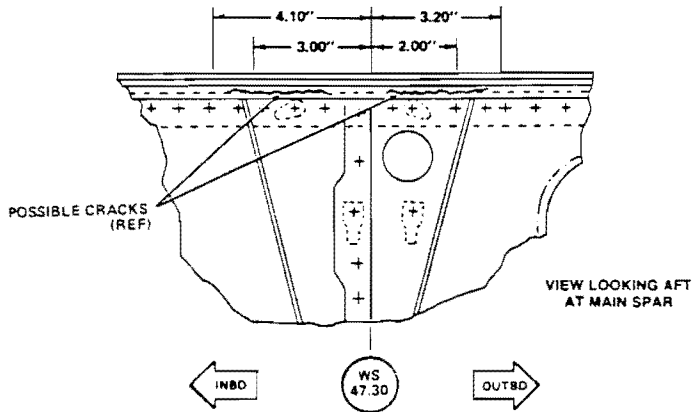
- b. If upper bolt holes are cracked and cracks are found in radius of spar cap and cracks in radius extend less than 4.1 inches inboard or 3.2 inches outboard but more than 3.0 inches inboard or 2.0 inches outboard of wing station 47.30 trace, comply with Part V of this Service Bulletin.

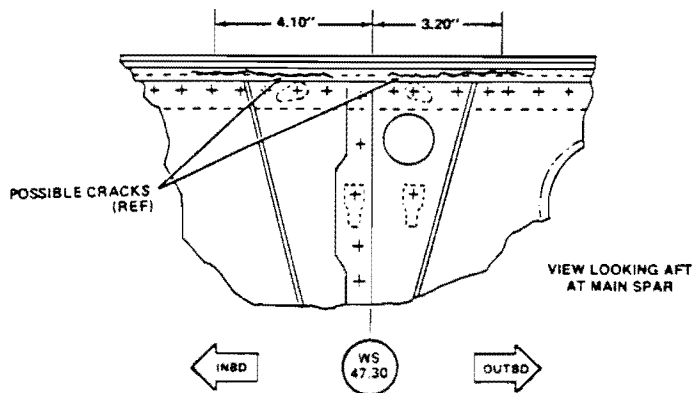
- c. If cracks are found in radius of spar cap and cracks extend MORE than 4.1 inches inboard or MORE than 3.2 inches outboard of wing station 47.30 trace, contact the factory.

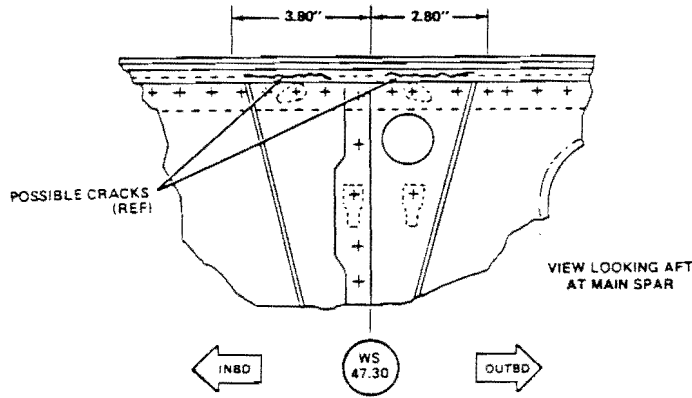
- d. If upper bolt holes are NOT cracked and if cracks are found in radius of spar cap and cracks extend less than 3.8 inches inboard or less than 2.8 inches outboard of wing station 47.30 trace, comply with Part II of this Service Bulletin.

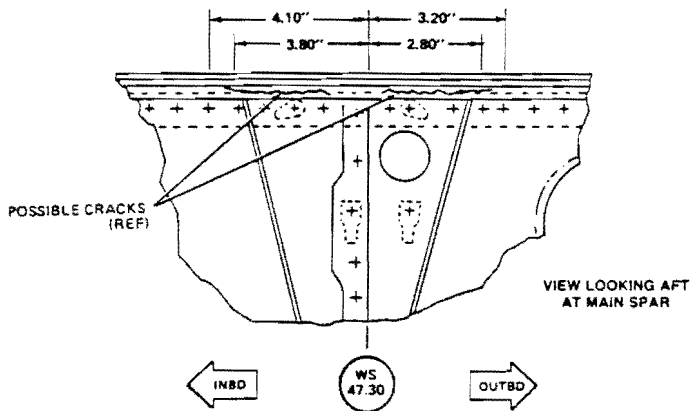
- e. If upper bolt holes are NOT cracked and if cracks are found in radius of spar cap and cracks in radius extend MORE than 3.8 inches inboard or MORE than 2.8 inches outboard but less than 4.1 inches inboard or less than 3.2 inches outboard of wing station 47.30 trace, comply with Part V of this Service Bulletin.
