P/N SP-114

**COMMANDER 114 SERIES
SERVICE PUBLICATIONS**

The following is a numerical list of all active Service Bulletins.

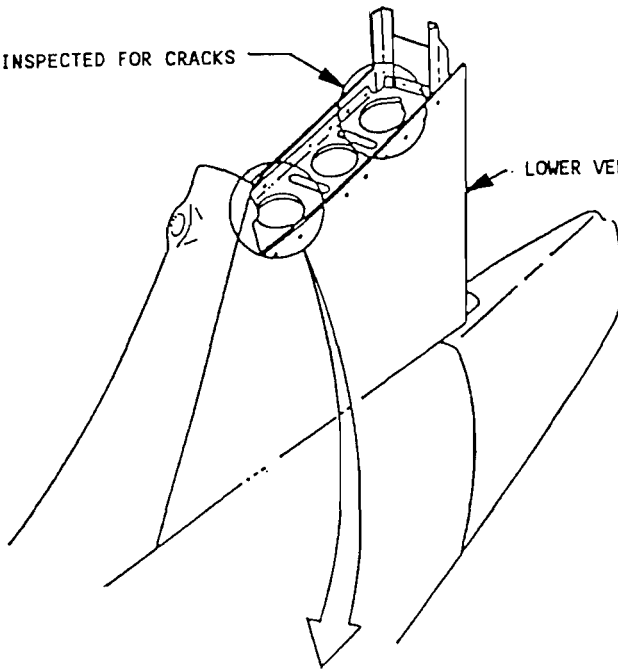
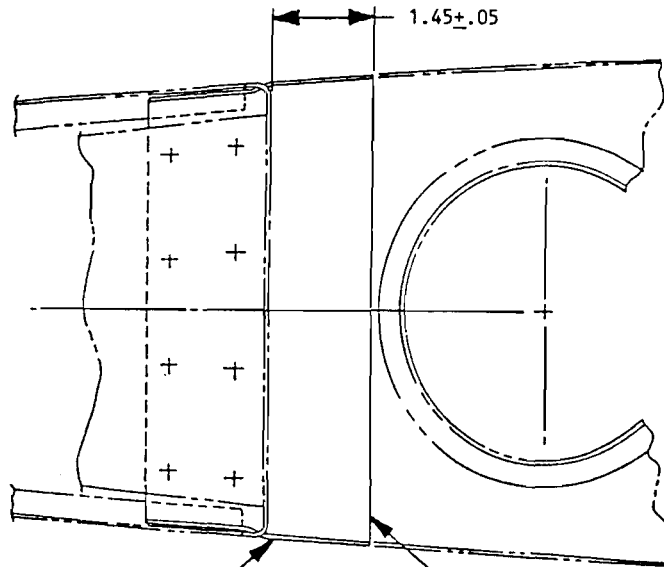
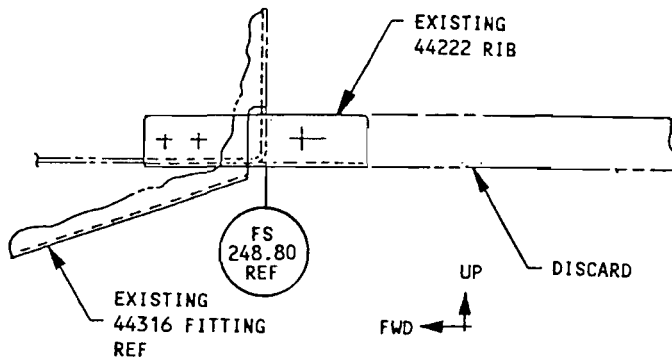
Figure 1

AREA TO BE INSPECTED FOR CRACKS

1. Remove Stinger and Rudder Assembly per MM Section VII.
2. Inspect Rib for cracks. On those aircraft with the 44004-RE 7 Rib installed per SB-114-12A, inspect for cracking beyond coverage of 44004-RE 7 Rib and cracking beyond any stop drilled holes. (Ref. Figure I.)
3. If cracks are found proceed to Part II.
4. If no cracks are found, reinspect every annual or proceed with Part II.
5. Reinstall Rudder, and Stinger Assemblies.
6. Fill out Compliance Card - Part I.

TRIM EXISTING RIB TO HERE

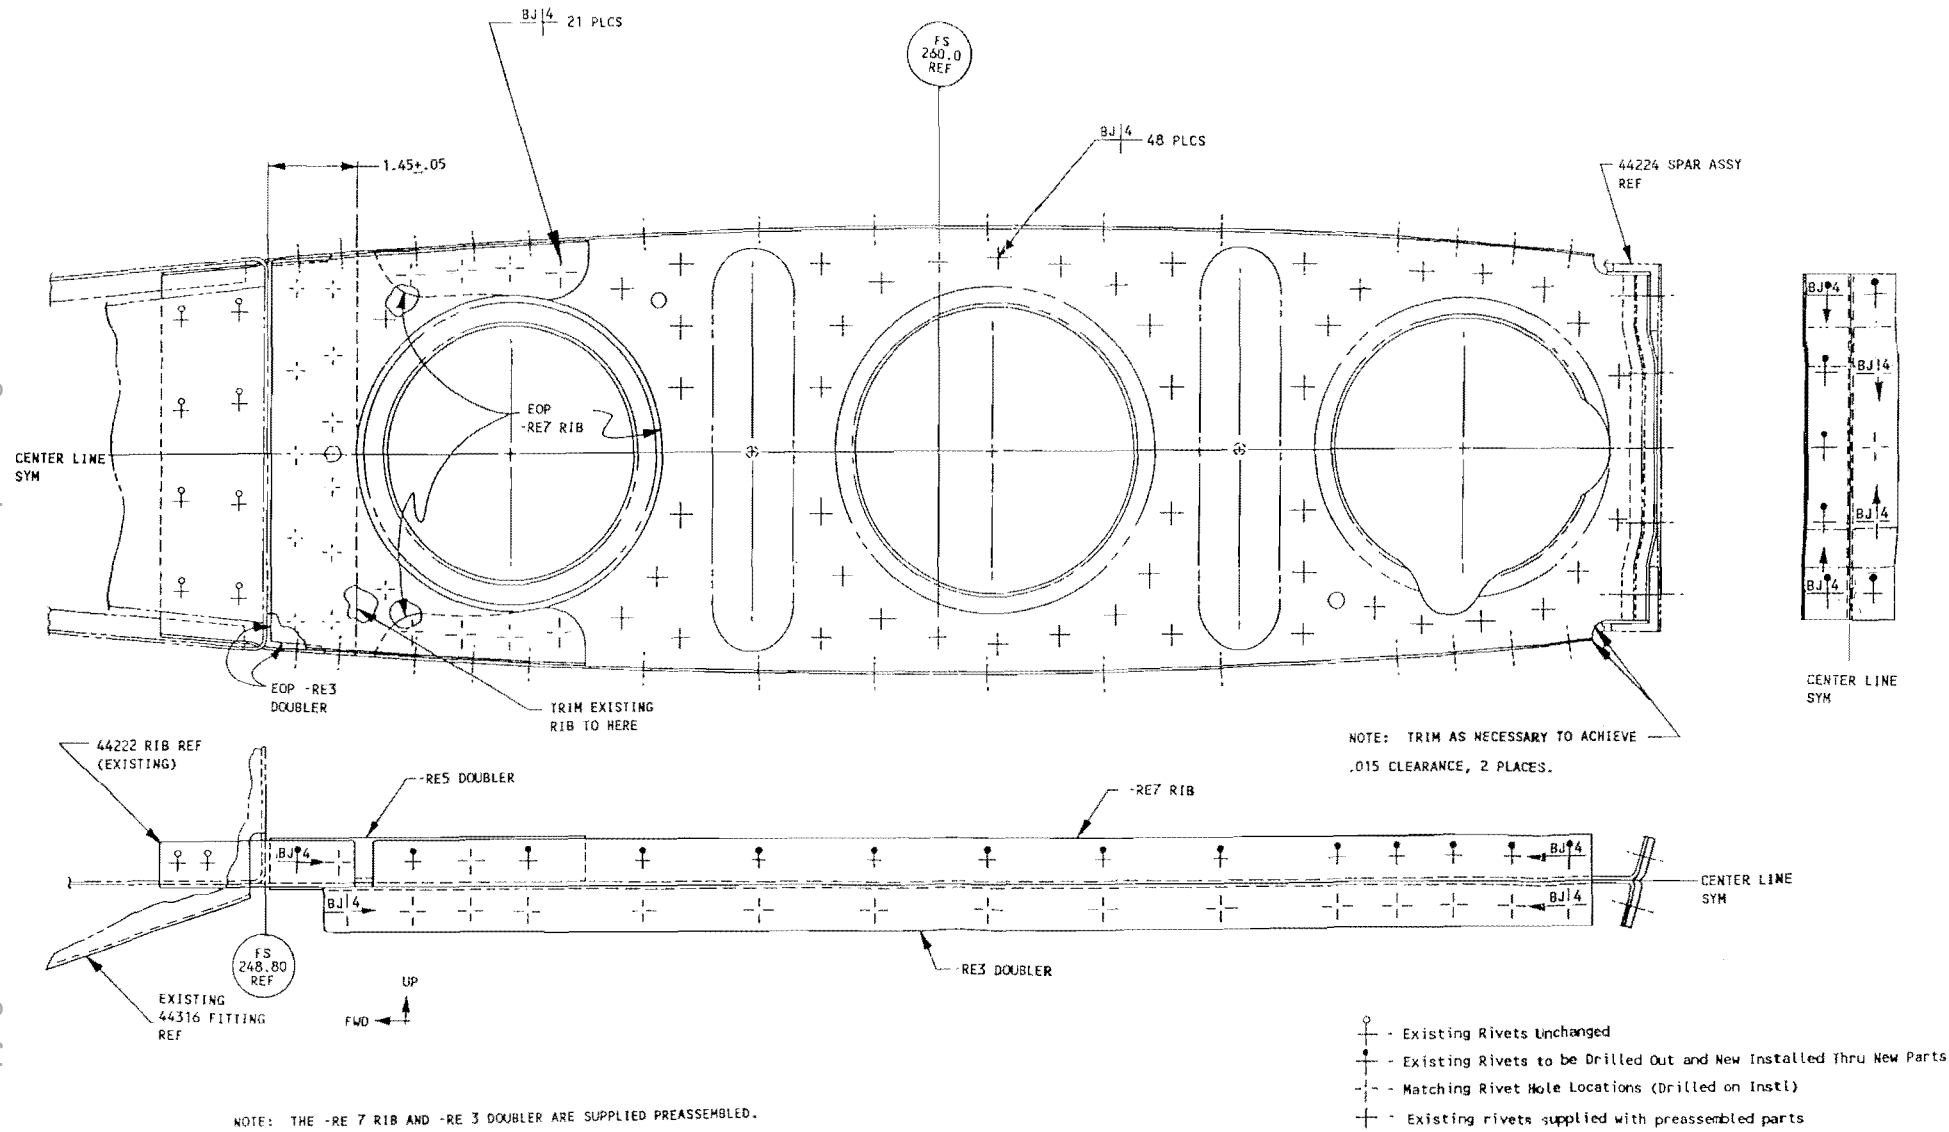
Figure 2

PART II: *Compliance with Part II of this SB is required within 100 hours if rib or doubler is cracked as described in Part I.*

PART II - DOUBLER AND RIB INSTALLATION

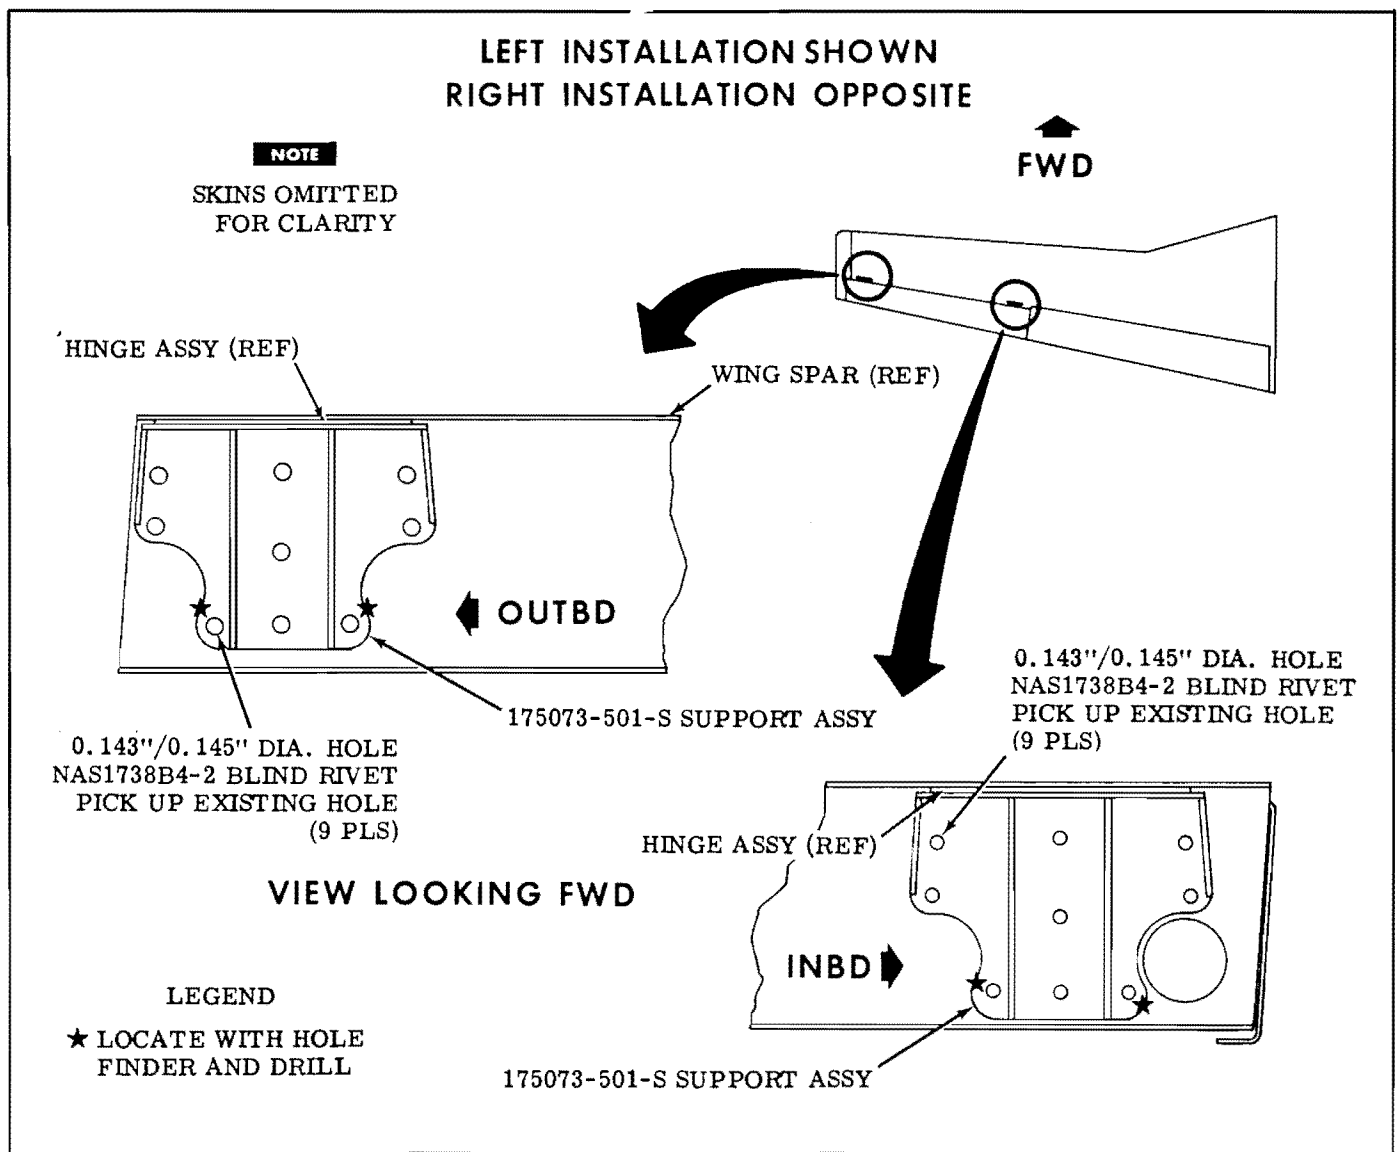
Figure 2.

REASON FOR PUBLICATION: POSSIBLE CRACKING OF AILERON HINGE SUPPORTS.

2. Remove existing aileron horns from ailerons.
3. Remove all existing aileron hinge supports from aileron and wing spars and retain supports for use as drill templates.

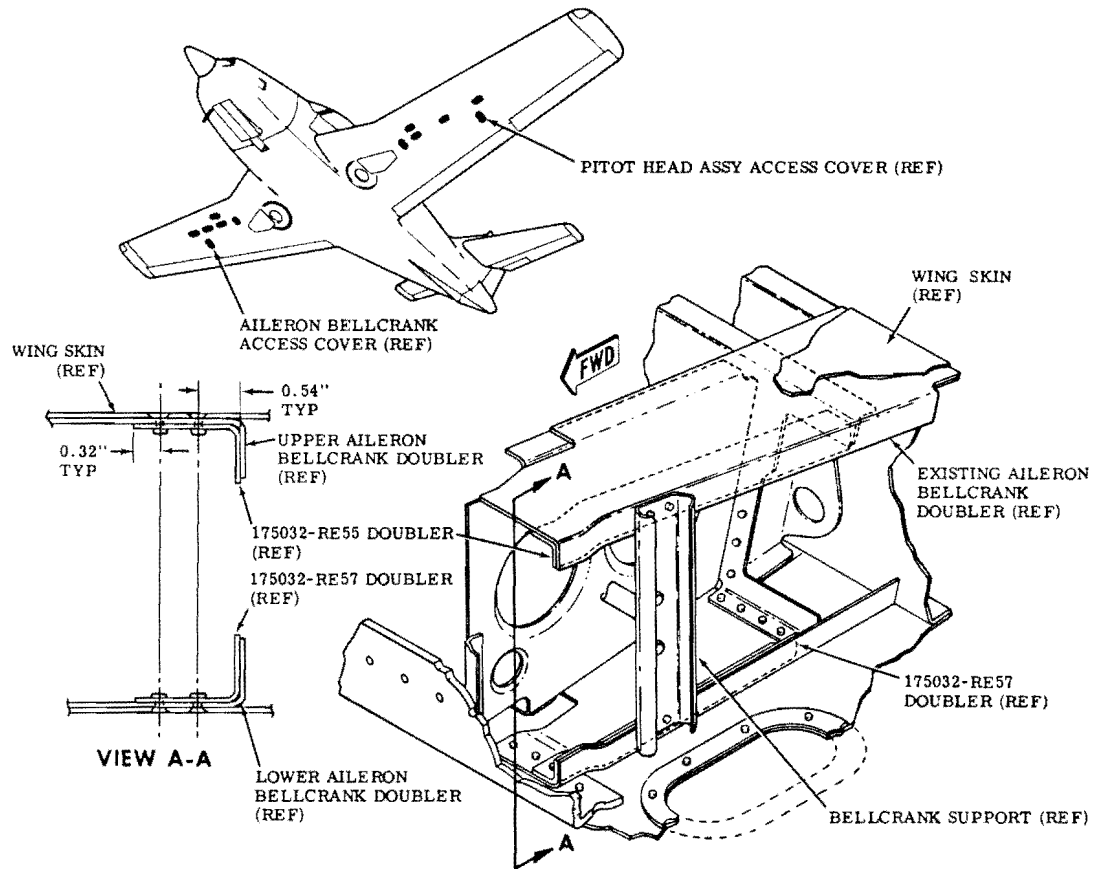
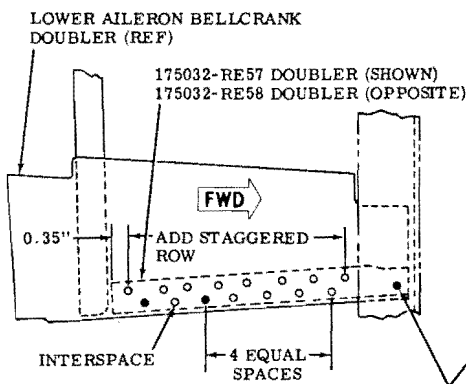
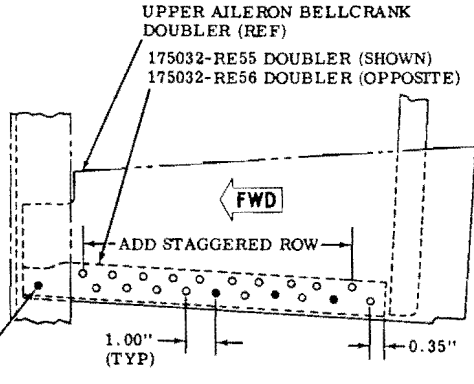
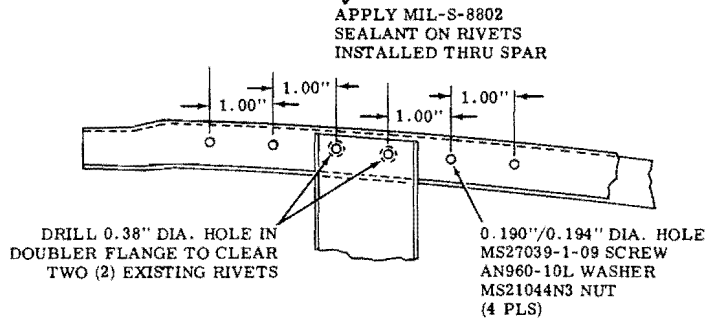
MODELS AFFECTED: MODEL 114A, SERIAL NO'S 14501 THRU 14511.
REASON FOR PUBLICATION: POSSIBLE CRACKS IN AILERON BELLCRANK DOUBLERS.
COMPLIANCE: WITHIN NEXT TWENTY-FIVE (25) HOURS TIME IN SERVICE.

- NOTES**
- USE MS20470AD4 RIVETS OR NAS1738B4 BLIND RIVETS TO INSTALL DOUBLERS
 - INDICATES EXISTING RIVET LOCATION
 - TRIM DOUBLERS AS NECESSARY FOR CLEARANCE

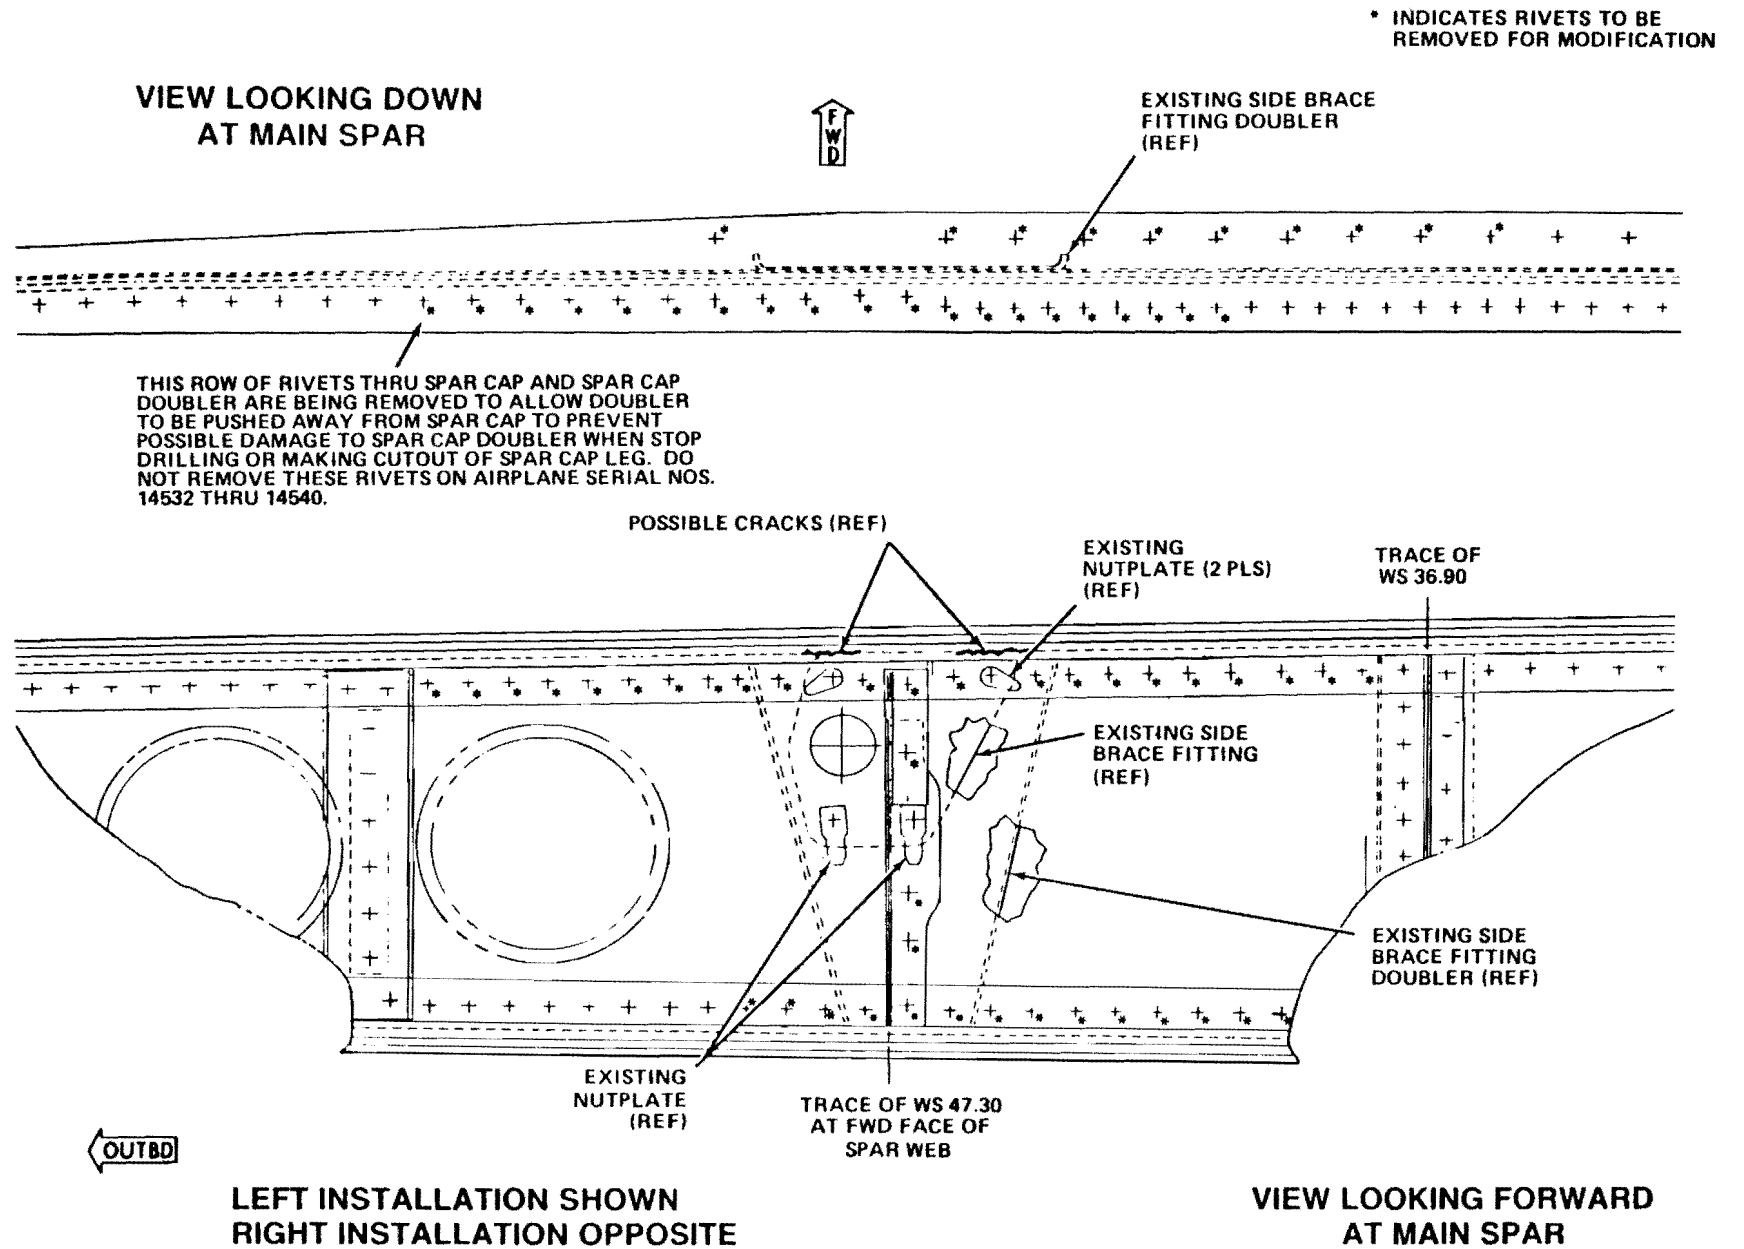
REASON FOR PUBLICATION: POSSIBLE CRACKS IN FORWARD WING SPAR, EITHER AROUND BOLT HOLES OR DIRECTLY ABOVE THEM.

Care should be taken so as not to damage hydraulic lines when making cutout in step 6. When making cutout, dimensions shown in Figure 1. must be followed very closely so as not to cut into spar cap flange.

6. If necessary to facilitate inspection, make a cutout in side brace fitting doubler and in spar web to be used as an inspection hole as shown in Figure 1. Using an inspection mirror and flashlight or boroscope, inspect side brace fitting upper attach holes for cracks around holes in upper spar cap. Inspect aft side of spar cap (refer to Figure 1).

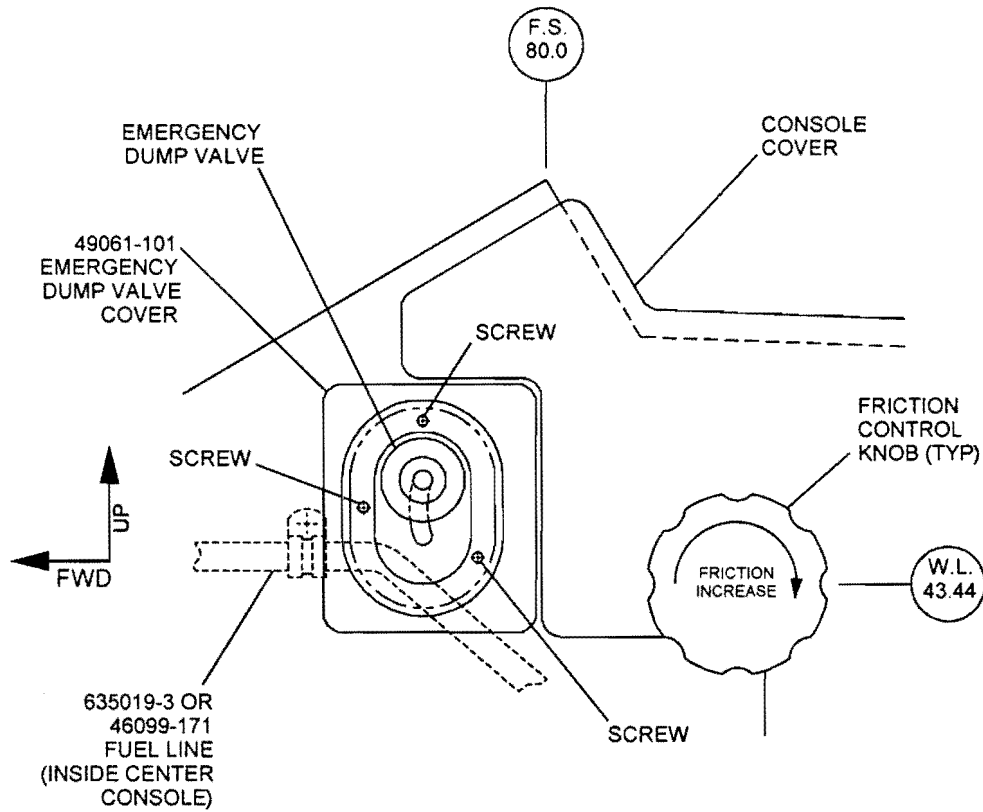
Figure 1
View looking inboard at Emergency Dump Valve

REASON FOR PUBLICATION: To inspect for possible fuel line damage caused by improperly installed emergency dump valve cover plates.

1. Verify that the hole pattern for the screws attaching the 49061-101 Emergency Dump Valve Cover to the center console match the hole pattern shown in Figure 1. Loosen the screws and verify that there are no additional holes to indicate that the 49061-101 Emergency Dump Valve Cover was installed upside down at some point.
2. If the hole pattern matches the pattern shown in Figure 1 and no additional holes are found, proceed to the RECORD COMPLIANCE section.
3. If the hole pattern does not match the pattern shown in Figure 1 or additional holes are found, proceed to Part II.

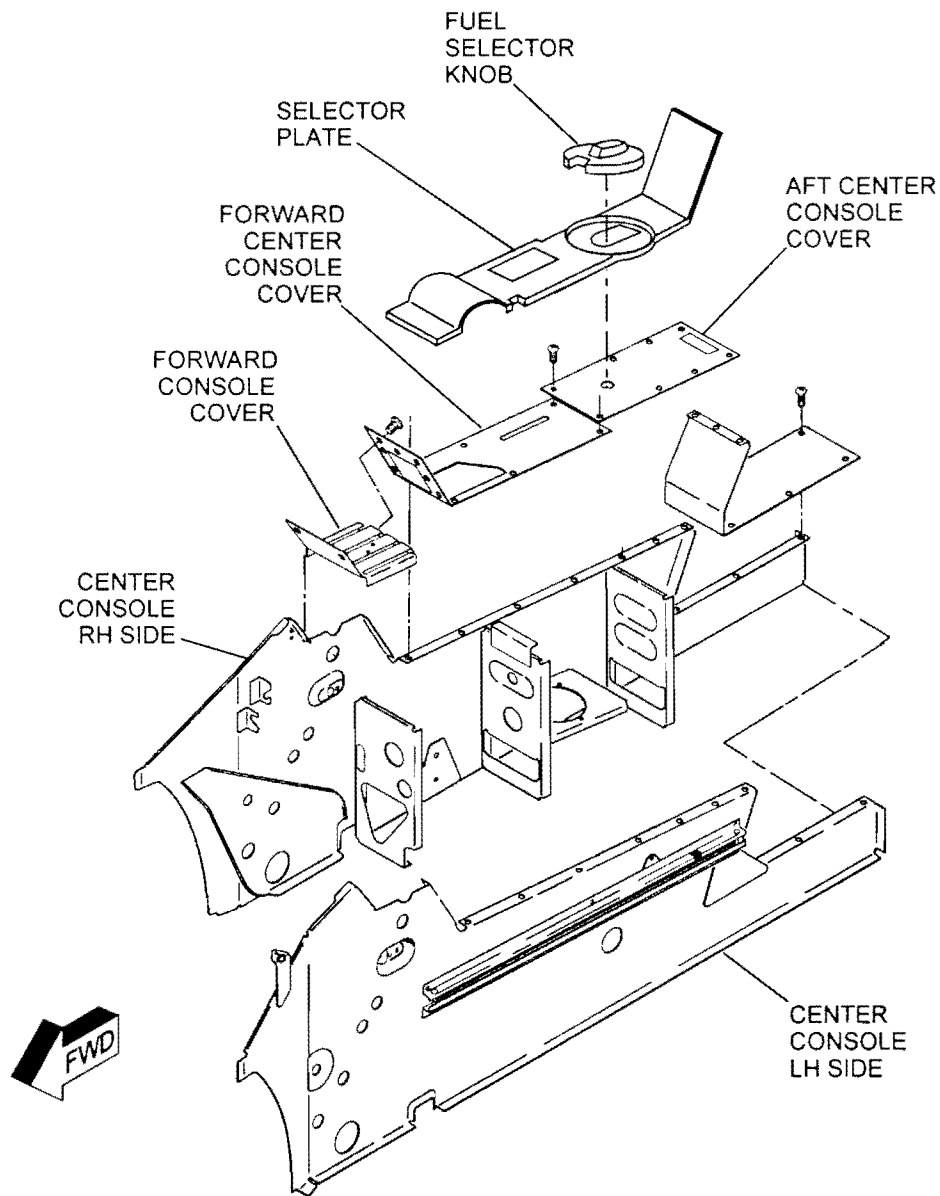
Figure 2.
(Console Cover Removed for Clarity)

8. Move the throttle lever forward until it clears the throttle warning microswitch. Raise the quadrant cover plate and the forward console cover to permit inspection of the 635019-3 or the 46099-171 Fuel Line for nicks or scratches in the area where the bottom screw attached the 49061-101 Emergency Dump Valve Cover to the center console.
 - a. If no damage to the fuel line is found, proceed to PART IV.
 - b. If a nick or scratch, is found in the area being inspected, or any other damage to the fuel line is found, proceed to PART III.

1. Remove the screw attaching the forward and aft center console covers to the center console and remove the covers from the center console. Refer to Figure 2.
2. Remove the two clamps securing the 635019-3 or the 46099-171 Fuel Line to the side of the center console.
3. Disconnect the ty-raps tying the static line to the 635019-3 or the 46099-171 Fuel Line.
4. Loosen the fitting connecting the 635019-3 or the 46099-171 Fuel Line to the fuel selector valve.
5. Loosen the fitting connecting the 635019-3 or the 46099-171 Fuel Line to the firewall union.

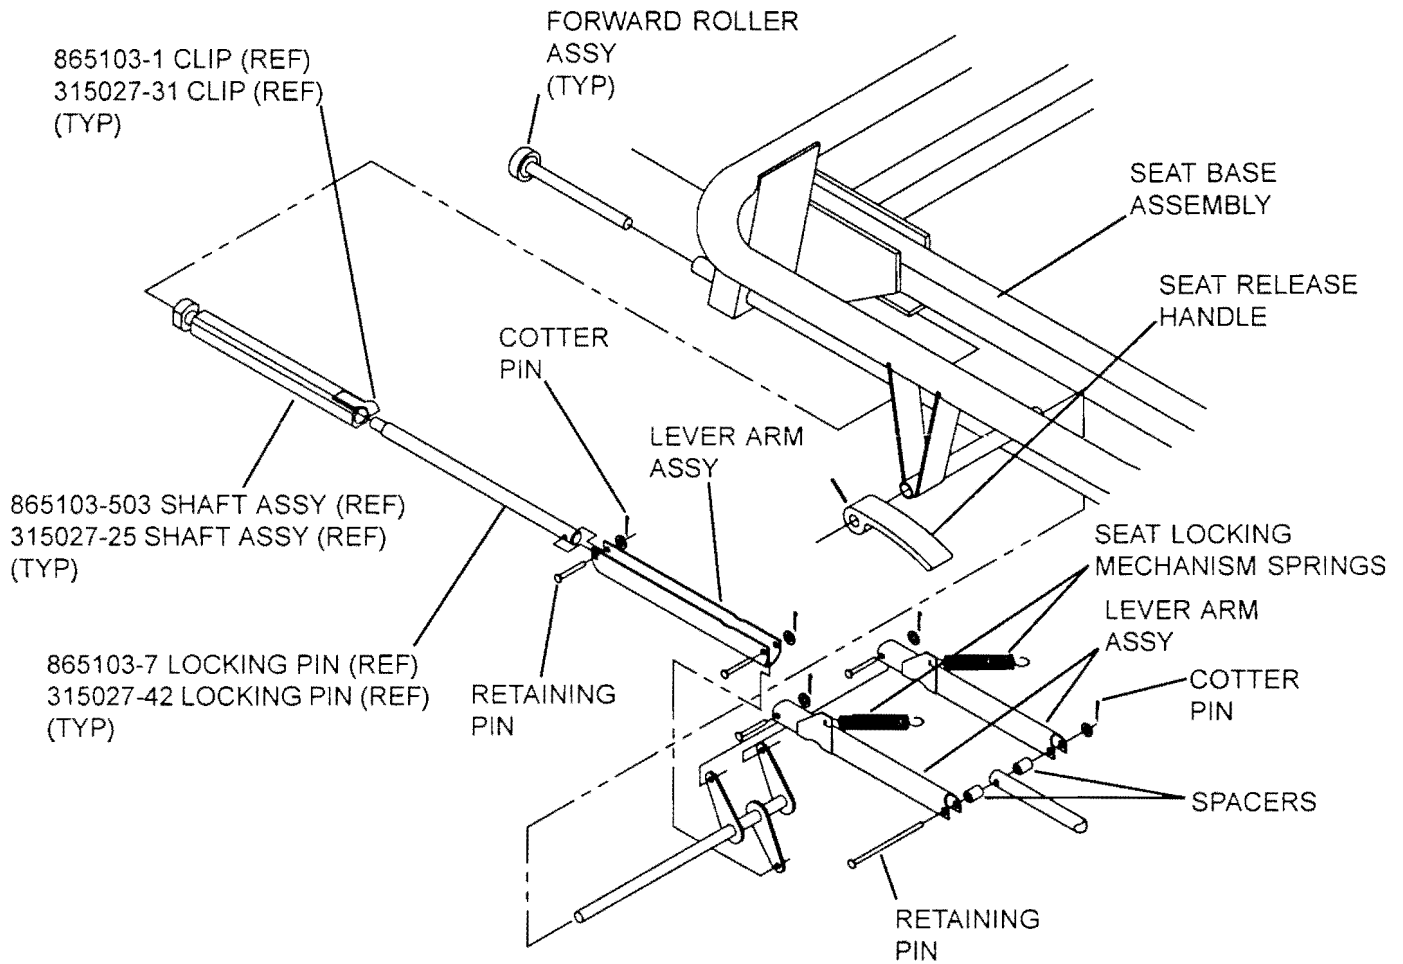
Figure 1. Seat Locking Mechanism

REASON FOR PUBLICATION: To inspect the 865103-503/315027-25 shaft assembly for proper operation. Improper operation can be caused by adjusting excessive clearance between the 865103-1/315027-31 clip and the 865103-7/315027-42 locking pin in the normal position or by flattening of the clips.

- a. Disconnect both seat locking mechanism springs from the Seat Base Assembly. (Refer to Figure 1.)
- b. Remove the cotter pins, retaining pins, and spacers at the two 865103-7/315027-42 locking pins. (Refer to Figure 1.)
- c. Position the 865103-503/315027-25 Shaft Assemblies in the locked position so that in the locked position, the 865103-1/315027-31 clip rides on the flat of the 315026-9 tube at the .24 dimension, shown in Figure 2. The curve of the clip may be adjusted to achieve the 90° dimension by carefully bending the curved end of the clip. After any adjusting of the clip, verify that the .06 minimum and .460 minimum dimensions are met.

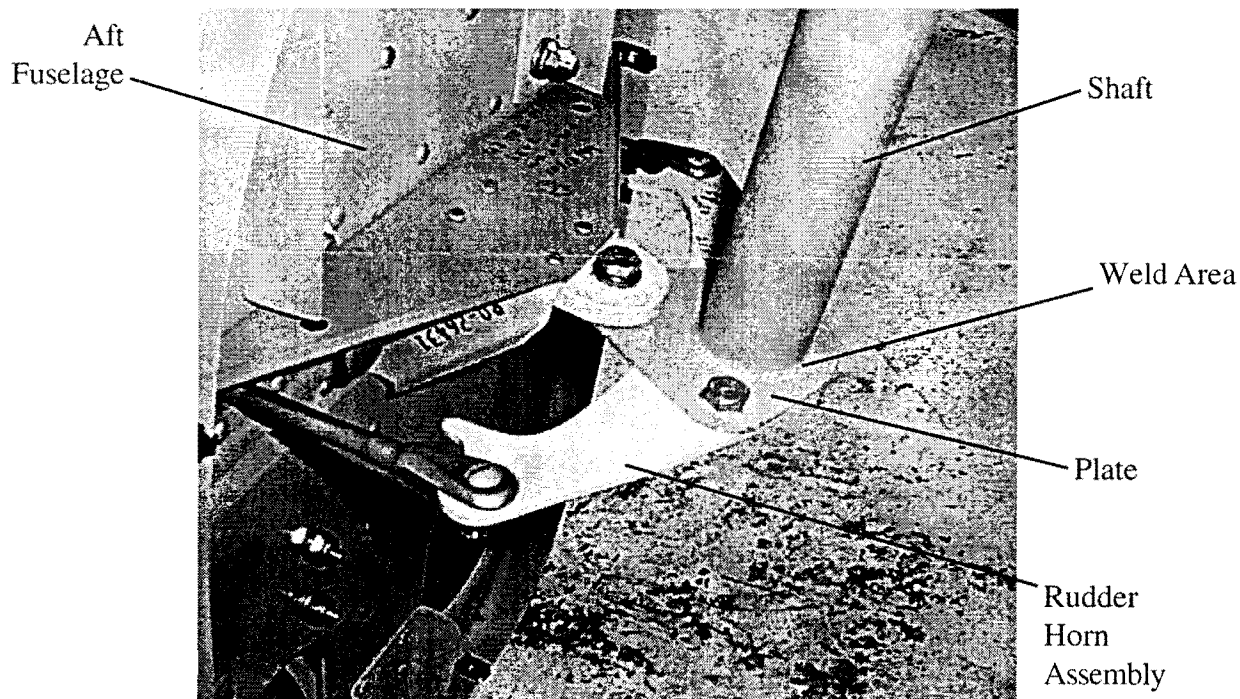
Figure 1

2. Visually inspect the weld area on the Rudder Horn Assembly as shown in Figure 1. The weld attaching the Shaft to the Plate should go around the shaft a full 360°.
3. If the weld is complete, reattach the tailcone assembly to the aft fuselage and fax the compliance form found on the last page of this Service Bulletin to Commander Aircraft Company. If a fax is unavailable, mail a copy of the compliance form to:

4. If the weld DOES NOT go around the shaft a full 360° contact Commander Aircraft Company **immediately** for repair instructions.

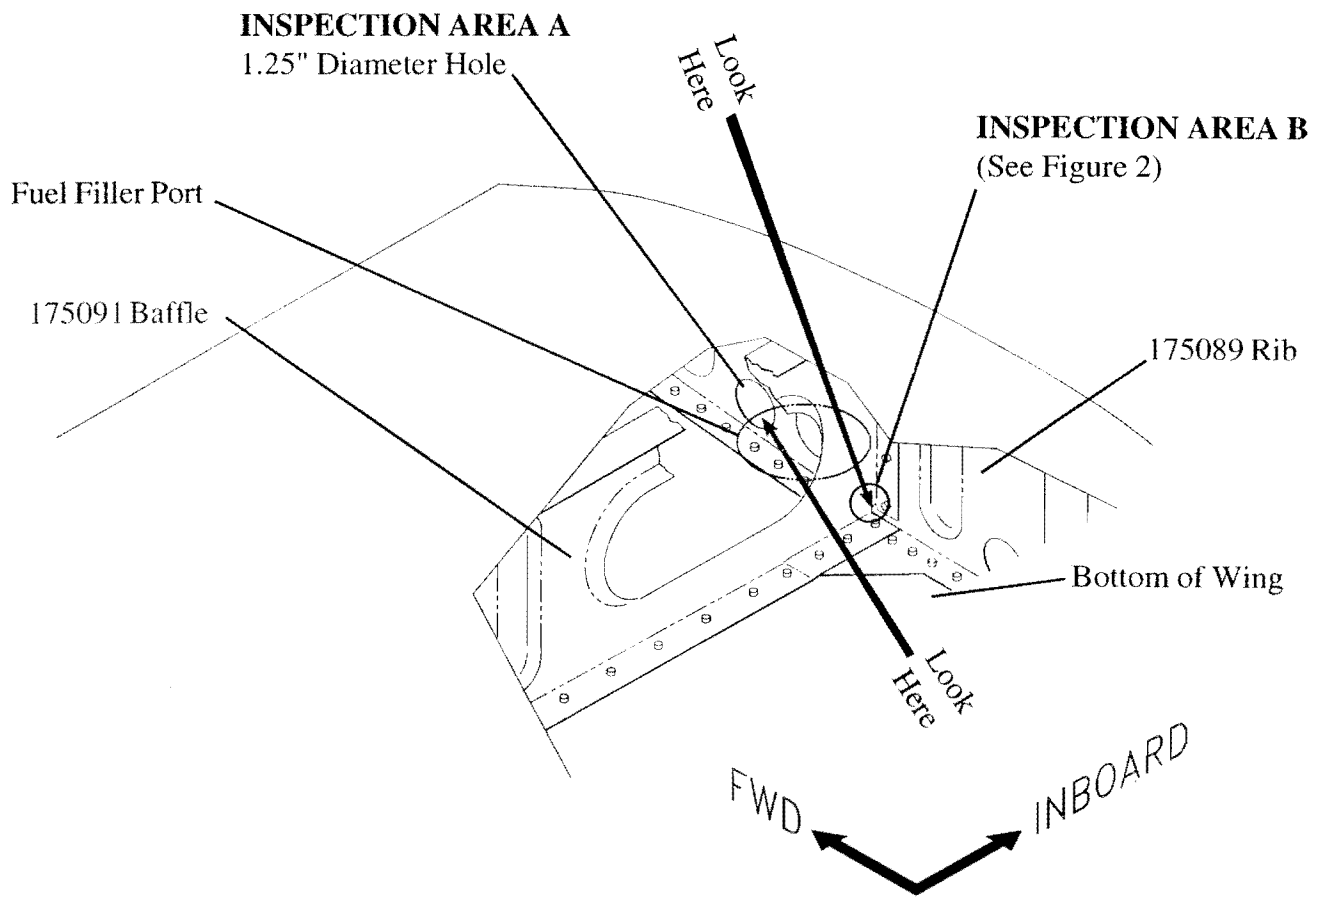
Figure 1.
Left Wing Shown
Fuel Port Flap Valve Removed for Clarity

REASON FOR PUBLICATION: To inspect for missing drain hole in 175089 rib.

1. Uncap the fuel filler port and push the flap valve down and forward as far as possible.
2. Refer to Figure 1, Inspection Area A. Using a flashlight, look down into the fuel tank through the fuel filler port and as far forward as possible past the 175091 Baffle. Inspect the 175089 Rib for a 1.25 inch diameter hole. If there is a 1.25 inch diameter hole in the rib, recap the fuel filler port and proceed to the RECORD COMPLIANCE section of this Service Bulletin. If there is no 1.25 inch diameter hole in the rib, proceed to PART II: INSPECTION OF THE 175091 BAFFLE.
